CASE STUDY

CLIENT	Private
SECTOR	Residential Bathrooms
LOCATION	Queenstown, NZ
APPLICATION	Vanity Unit Drawers
FINISH	Water Aged
COLOUR	Brass

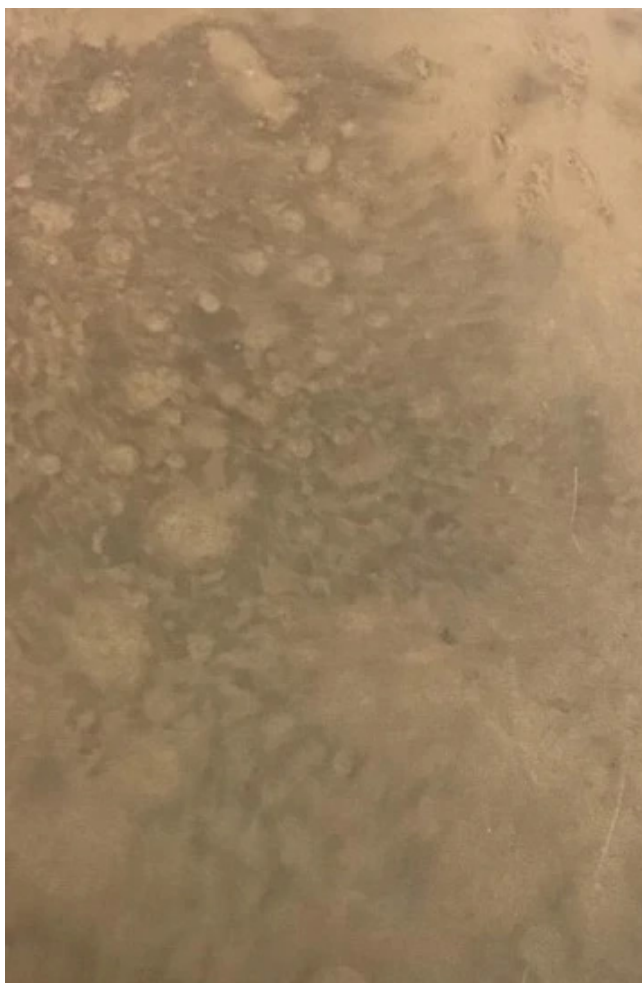
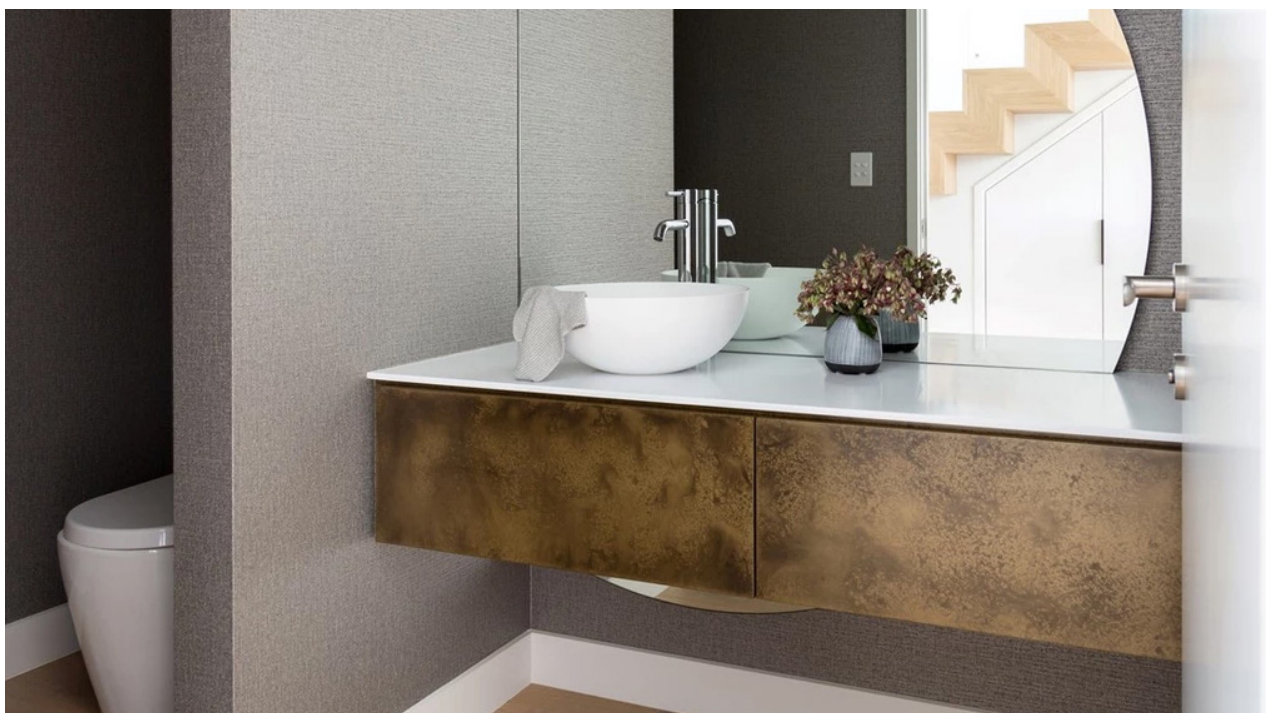
Metalier coatings can be used in wet areas such as bathrooms. Here Water-aged Brass is applied effectively to drawer fronts in a powder room. Water-aged finishes can be created with most finishes provided they can be applied horizontally. After a light sanding and water-aging, the finish is sealed with a semi-gloss clear coat.

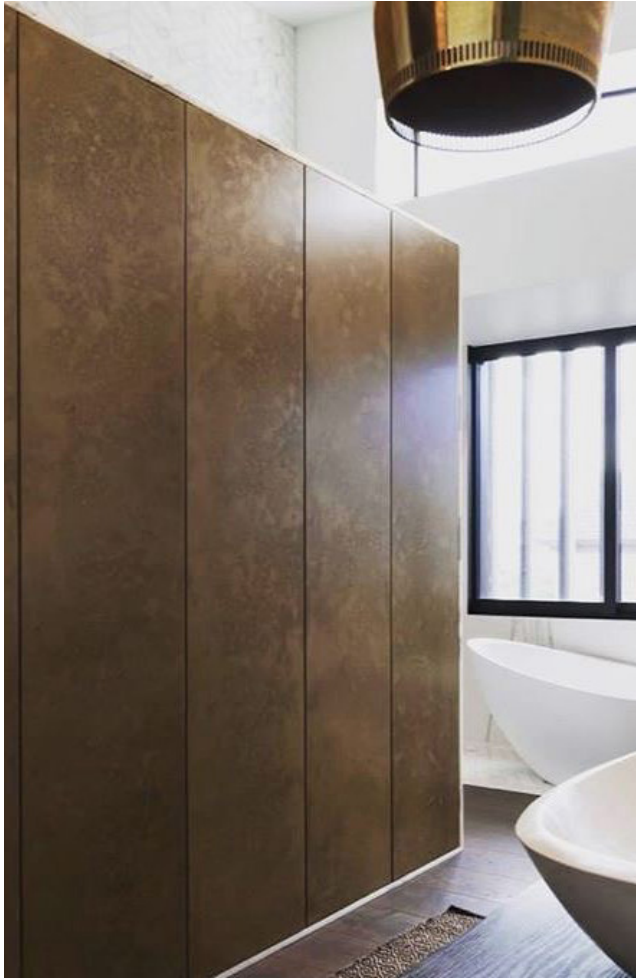
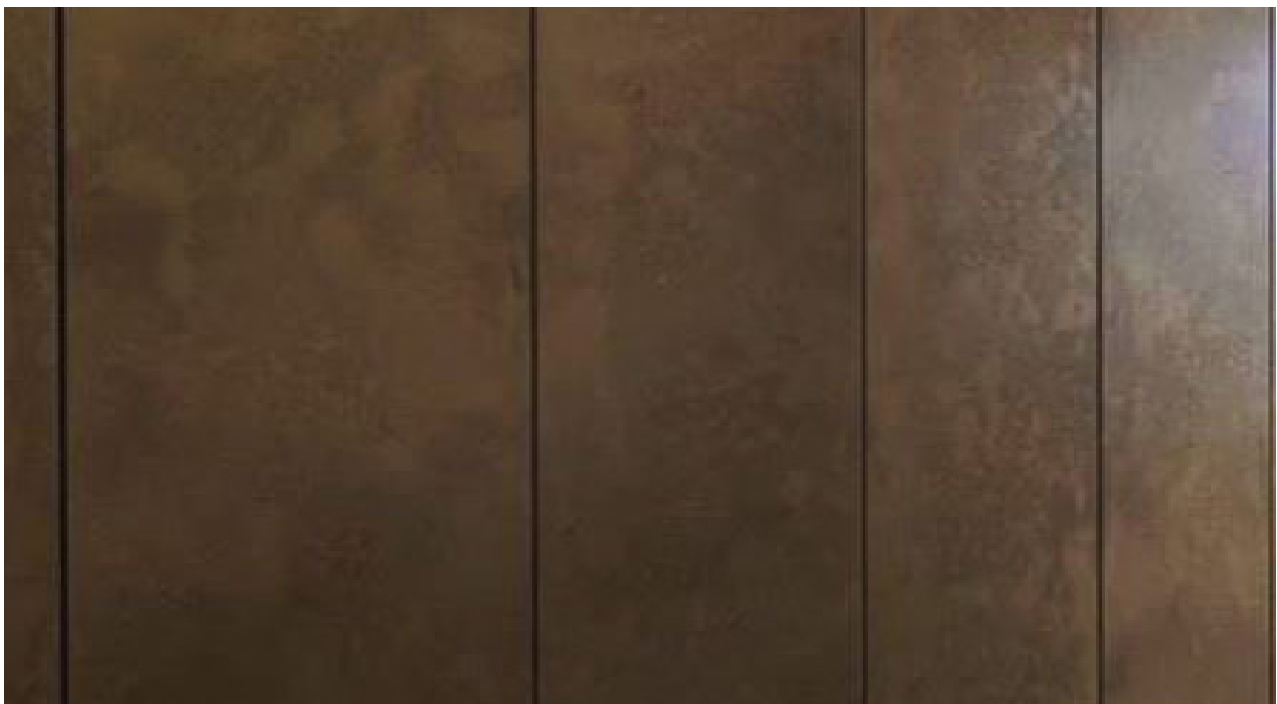
Water-aged Bronze was used to create these oversized doors for a bathroom. The doors, once sanded, were laid down together so that they could have patina applied to them all at the same time. The patinating of adjoining panels must be done at the same time. This is because ambient temperatures and humidity affect how and how quickly a patina reacts. This is metal as art. These doors were sealed with a semi-gloss clear coat.

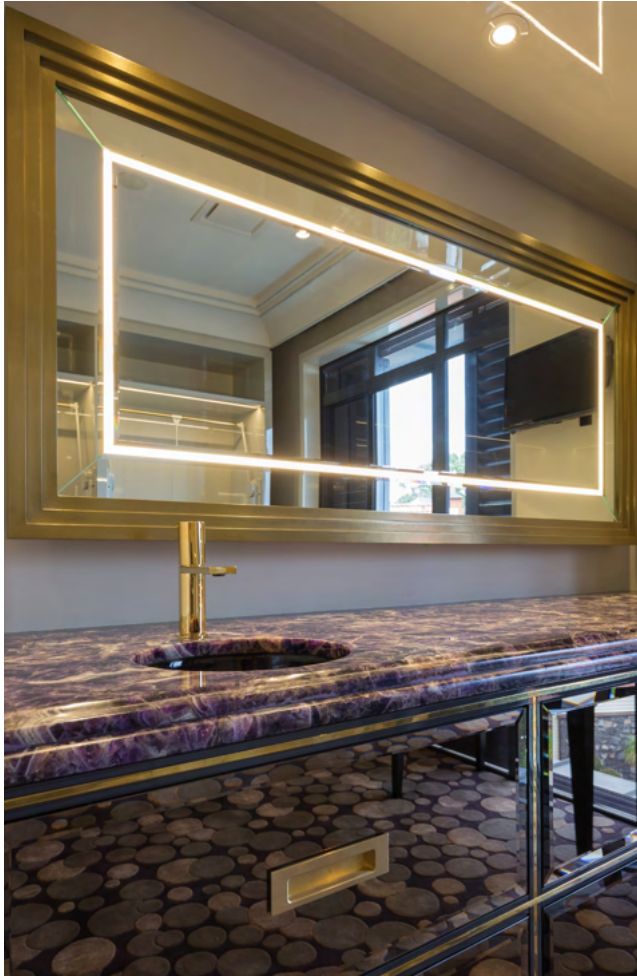
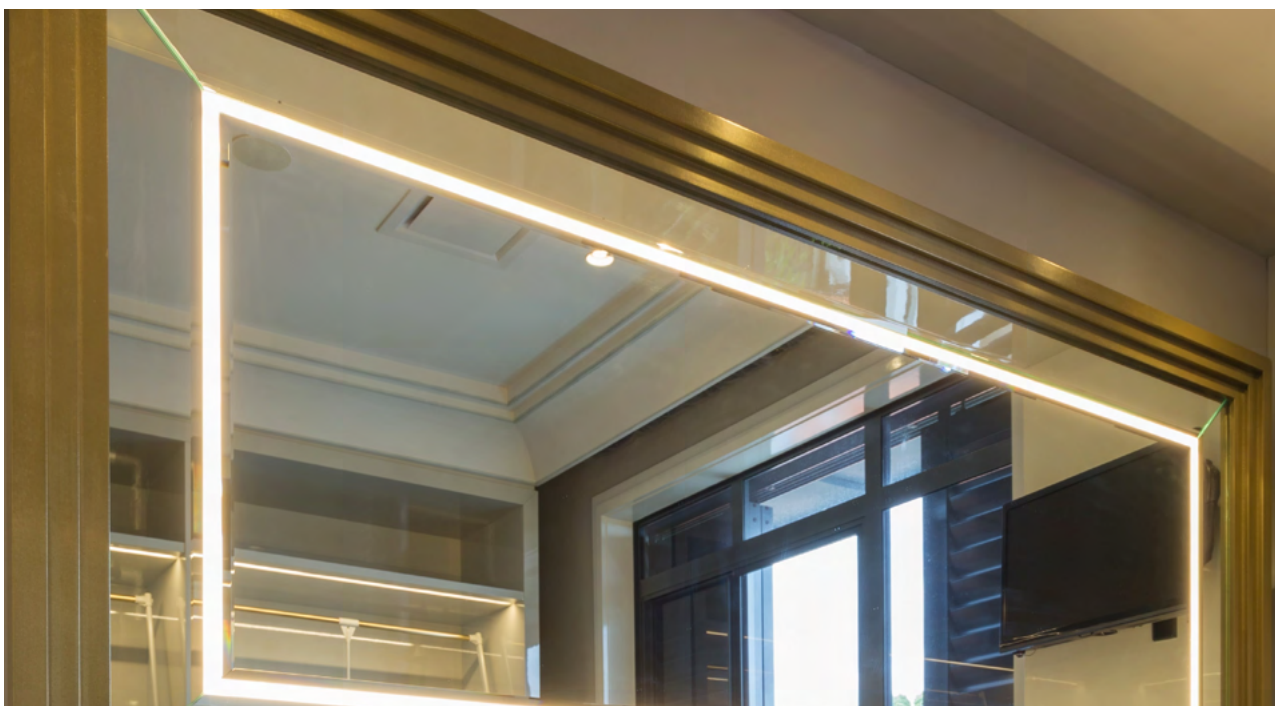
These mirror frames were coated with Metalier in Classic Gold. They were hand-finished to a high level and then clear coated with a gloss sheen. Hand sanding with very small tools was required because of the intricate design of the frame.
