## Metalier International

#### CASE STUDY

CLIENT	Harrods
SECTOR	Retail
LOCATION	London, UK
APPLICATION	Escalators
FINISH	Smooth Polish
COLOUR	Champagne Gold

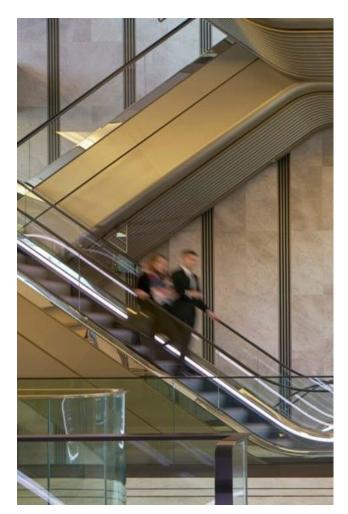
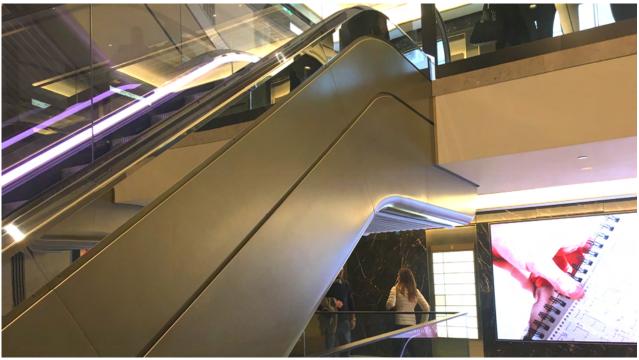
The underneath and sides of a bank of escalators in Harrods, London were coated with Metalier Champagne Gold with a satin clear coat. There were five stories of escalators and the roof of the famous retail store was removed to allow installation.

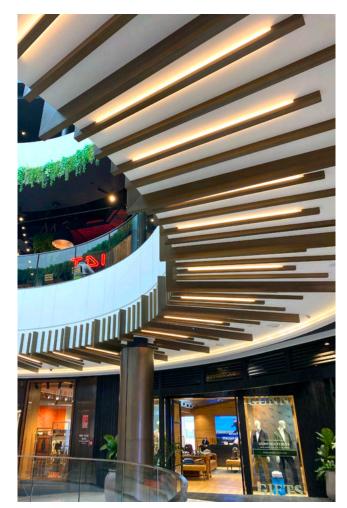
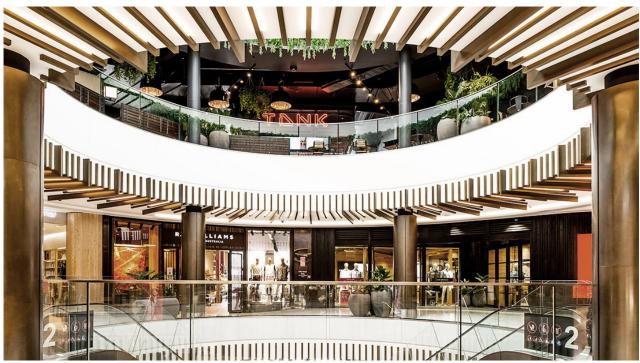
CLIENT	Westfield Newmarket
SECTOR	Retail
LOCATION	Auckland, NZ
APPLICATION	Ceiling Ribs
FINISH	Aged
COLOUR	Bronze

Metalier Aged Bronze was used on decorative ceiling panels in the atrium of a bank of escalators in a city mall. The bronze was patinated to give an aged look and the finish was sealed with a satin clear coat. The substrate was mild steel and the L shape was created in two separate pieces that were married up during installation.

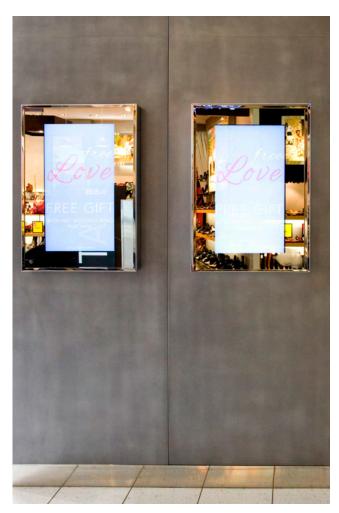
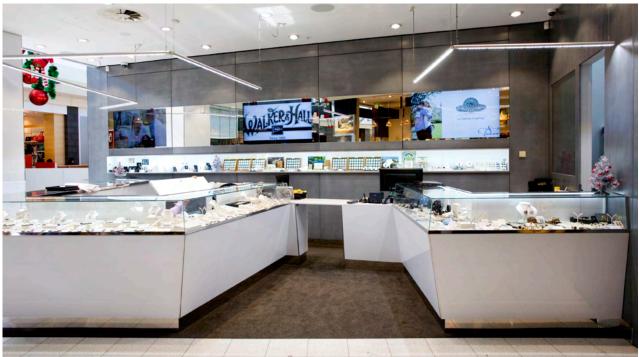
CLIENT	Walkers - Partition Walls
SECTOR	Retail
LOCATION	Auckland, NZ
APPLICATION	Partition Wall
FINISH	Light Aged
COLOUR	Aluminium

The designer used Lightly-aged Metalier Aluminium on MDF as a backdrop in this jewellery store. It is situated within a shopping mall. The dulled aluminium look allows the sparkling jewellery merchandise to take centre stage. The metal finish was lightly sanded and then diluted patina was applied. A satin clear coat was used.
